DEPARTMENT OF TRANSPORTATION**DIVISION OF ENGINEERING SERVICES**

Contract #: 04-0120F4Cty: SF/ALA Rte: 80 PM: 13.2/13.9File #: 69.28**WELDING INSPECTION REPORT****Resident Engineer:**Pursell, Gary**Address:** 333 Burma Road**City:** Oakland, CA 94607**Report No:** WIR-003834**Date Inspected:** 07-Sep-2008**Project Name:** SAS Superstructure**OSM Arrival Time:** 2300**Prime Contractor:** American Bridge/Fluor Enterprises, a JV**OSM Departure Time:** 730**Contractor:** Zhenhua Port Machinery Company, Ltd (ZPMC), Changxing Island **Location:** Shanghai, China**CWI Name:** Chen Xi**CWI Present:** Yes No**Inspected CWI report:** Yes No N/A**Rod Oven in Use:** Yes No N/A**Electrode to specification:** Yes No N/A**Weld Procedures Followed:** Yes No N/A**Qualified Welders:** Yes No N/A**Verified Joint Fit-up:** Yes No N/A**Approved Drawings:** Yes No N/A**Approved WPS:** Yes No N/A**Delayed / Cancelled:** Yes No N/A**Bridge No:** 34-0006**Component:** OBG**Summary of Items Observed:**

Caltrans Quality Assurance (QA) Inspector, Larry Viars was present to observe the Production Monitoring Test (PMT) for Orthotropic Box Girder (OBG) Deck panels, for the San Francisco Oakland Bay Self Anchor

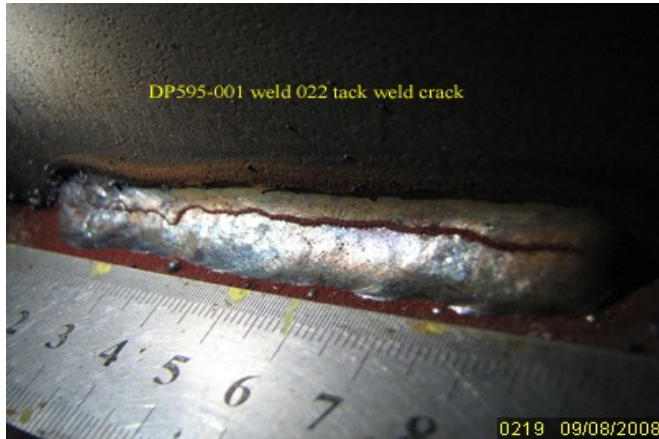
Sub Assembly Bay 1- During random visual observations the Caltrans QA Inspector found a 90 mm tack weld crack on Deck panel DP595-001 stiffener weld 022 located on gantry # 1. The crack was shown to ZPMC QC Chen Xi. Mr. Chen stated that the crack would be removed and Magnetic particle testing would be performed. Please see the attached photo below of the tack weld crack.

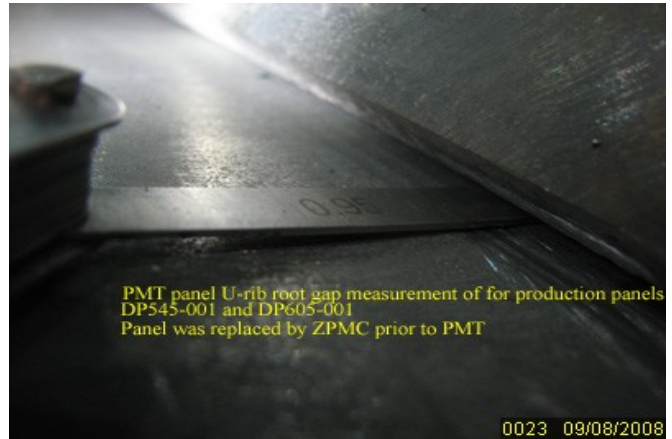
The Caltrans QA Inspector monitored the OBG Production Monitoring Test (PMT) for Deck Panels DP545-001 and DP605-001. Prior to GMAW welding two u-rib panels were found to have a root gap of up to .95 mm. The majority of gaps in excess of .5 mm appear to adjacent to tack weld ends where grinding has been performed to remove indications. The panels were replaced and were inspected by ZPMC, ABF and CT. The Caltrans QA inspector recorded amperage, voltage and travel speed of the Gas metal Arc Welding (GMAW) root pass and the Submerged Arc Welding (SAW) cover pass. A Visual inspection of the root pass and cover pass was performed by ZPMC, American Bridge Flour (ABF) and the Caltrans QA. The Caltrans QA observed ZPMC QC Xue Hai Rong perform Ultrasonic testing of the Partial Joint Penetration weld for depth of penetration. Mr. Xue found the depth of penetration of the PMT welds to be in compliance with contract documents. The Caltrans QA inspector designated locations for Macroetch samples (15 locations). Macroetch samples were evaluated with a 7x optical

comparator and accepted by ZPMC QC, ABF QC and The Caltrans QA Inspector. Please see attached photo of .95 mm gap of PMT panel prior to replacement by ZPMC.
